RE: PDR 1620712, 1929 Vassar Street

The Staff Report indicates that the Craftsman Bungalow at 1929 Vassar Street is a historic resource and exempt from CEQA review pursuant to Section 15331, Class 31 – Historical Resource Restoration/Rehabilitation. We agree that the subject property is a historic resource. However, the proposed project is neither a restoration nor technically a rehabilitation; nor is it "maintenance, repair, stabilization," "preservation, conservation, or reconstruction." In other words, it meets none of the appropriate goals associated with a Class 31 exemption. The proposed project is also not adaptive reuse, given that the property will remain a single-family house. According to the National Park Service, rehabilitation as a treatment "is defined as the act or process of making possible a compatible use for a property through repair, alterations, and additions while preserving those portions or features which convey its historical, cultural, or architectural values" (<https://www.nps.gov/tps/standards/four-treatments/treatment-rehabilitation.htm>). Instead the proposed project involves the demolition of part of the subject property, more than 1,000 square feet

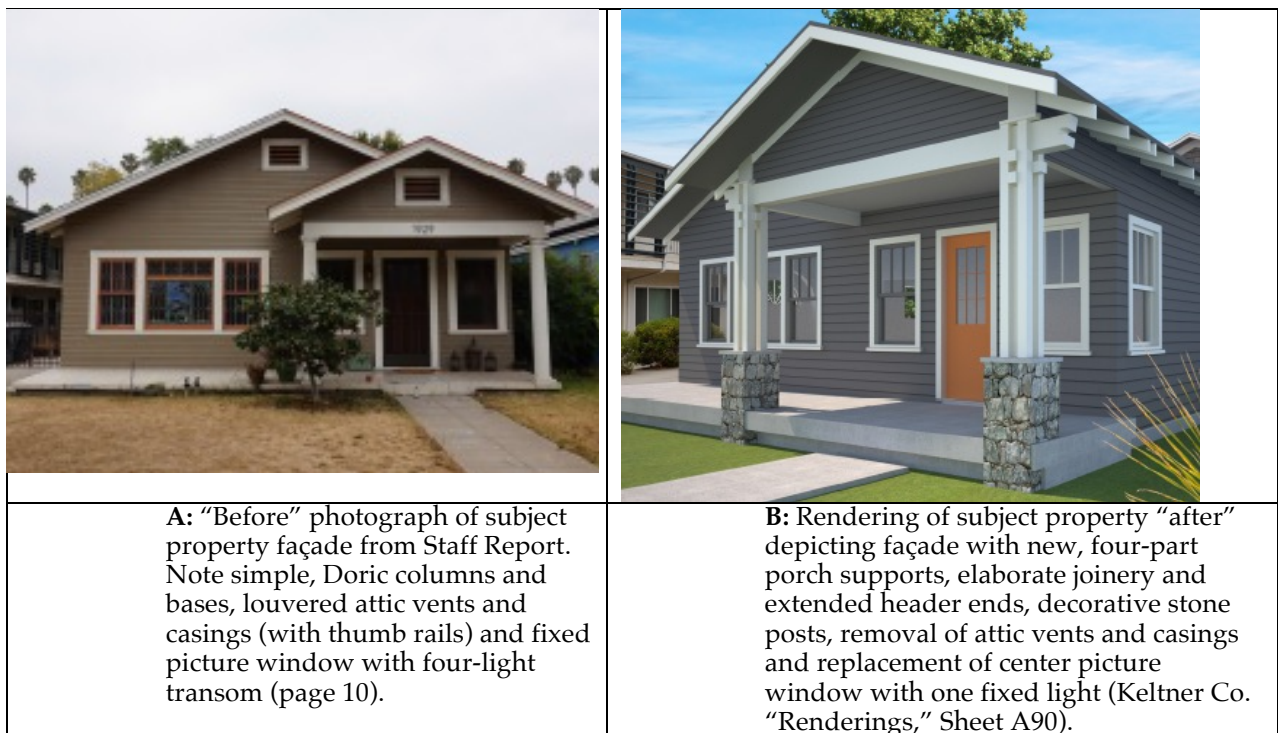
Finally, project renderings of the front façade show that the distinctive front porch Doric columns would be replaced by entirely new, four-part supports with decorative joinery, and the plain post-to-porch connection would be replaced by inappropriately low, decorative stone piers, the removal of two character-defining attic vents and the replacement of the picture window with a single light of glass, none of which existed historically (Figure 1, A and B). Those described alterations appear to have been proposed in order to make the existing 1922, high integrity Craftsman style house

Figure 1. Existing front façade of 1929 Vassar Street and rendering of new façade.

“match” the new side porch. We note that some of the renderings depict a standing seam roof, which would also be inappropriate for this building as it never existed historically. The alterations depicted in the renderings on Sheet A90 are entirely inappropriate; replacing historic features and materials with a contemporary “interpretation” of the Craftsman style disregards the most basic principles and practices of historic preservation
